# Project Phase I, Phase II, Validation

McInerney Homes (North Region)

Vulcan Street, Oldham

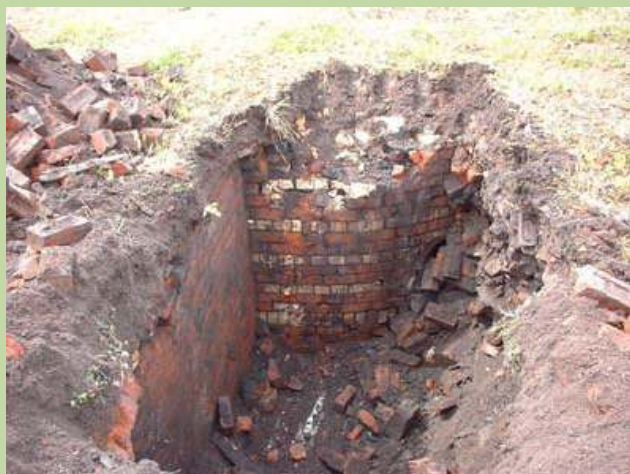
Granville Mill, with the accompanying mill ponds, boiler house, chimney and reservoirs, was unfit for restoration. The mill ponds were backfilled with waste and the site had become derelict due to a fire in 1999. The buildings and chimneys were subsequently demolished. The potential for sub-soil contamination and the presence of landfill gas was therefore identified on the site.

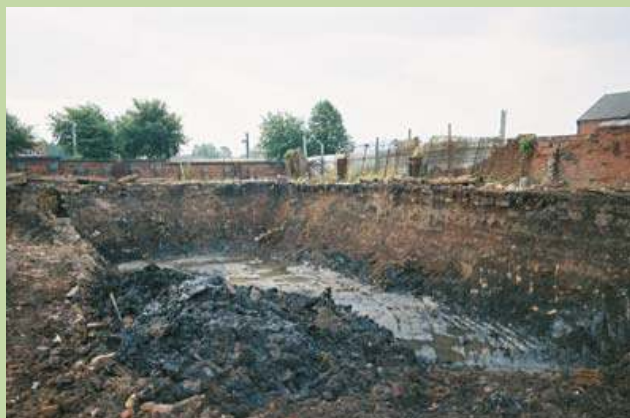
LK Associates investigated the site through the sinking of window sample boreholes, the excavation of trial pits, soil and water sample collection and analysis. Standpipes were installed on the site to enable the monitoring landfill gases. The geotechnical properties of natural ground were derived using in-situ and ex-situ geotechnical testing techniques. Soil sample analysis proved contaminants to be present in levels exceeding Environment Agency soil guideline values and site specific assessment criteria derived by LK Associates.

As a result of the risk assessment recommendations were put forward for remediating the site, with suitable recommendations made for capping layer depths and constituents.

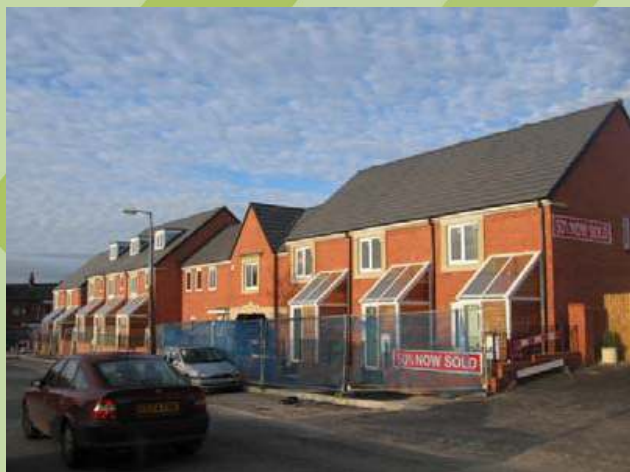
Due to the large areas of infilled land and underground brick structures such as chimney foundations and an ancient culvert, the geotechnical properties of the ground were deemed to be unsuitable.

LK Associates, together with McInerney Homes, devised a remedial strategy which was approved by the Local Authority. This strategy incorporated the removal of hotspot contaminated areas in conjunction with the excavation, sorting and screening of the top 3-4m of made ground in the identified areas on the site. Replacement of the material was carried out in an engineered fashion to enable mini-piles to be used for the foundation option.
