Pollution Response – Clarence Mill Hydrocarbon Remediation

Client
NHBC
Cost
£6,500

Location
Clarence Mill, Bollington
Program
6 Weeks

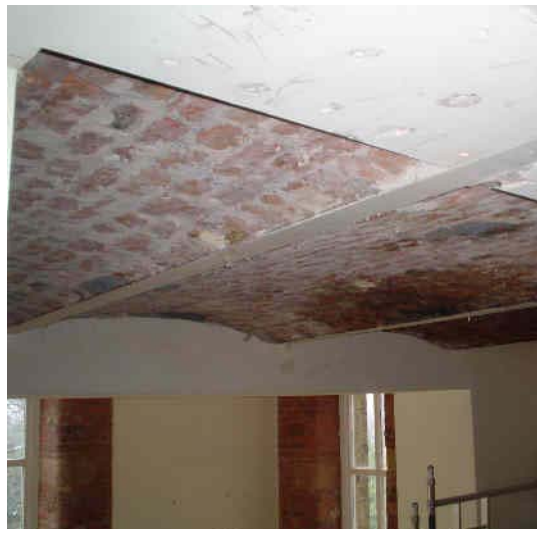
Hydrocarbon Affected
Areas

A number of apartments within the property were experiencing oil seeping through the brick vaulted ceilings and walls. This had caused the plaster skim to de-bond from the brick vaulted ceiling and presented a vapour risk to the residents of the property.

The oil had fallen onto the porous brick floor which had in turn leached through into the vaulted ceiling below.

LKPR began by clearing the apartment and protecting the floors, followed by removal of all remaining plaster and bonding that was used during construction to expose the bare brick.

Injection holes were then installed to the entire vaulted ceiling to a depth of 100mm which would allow a surfactant to be impregnated within the brick.

Surfactants were also sprayed onto the face of the brick to break down the hydrocarbon, in addition, micro-organisms were also sprayed onto the brickwork to actually digest the contamination.

Within a 6 week period the micro-organisms had digested the vast majority of the Hydrocarbon which allowed a special epoxy to be applied to the ceiling. This epoxy acted as a tank to the ceiling with an internal drain catching any future migration of oil.

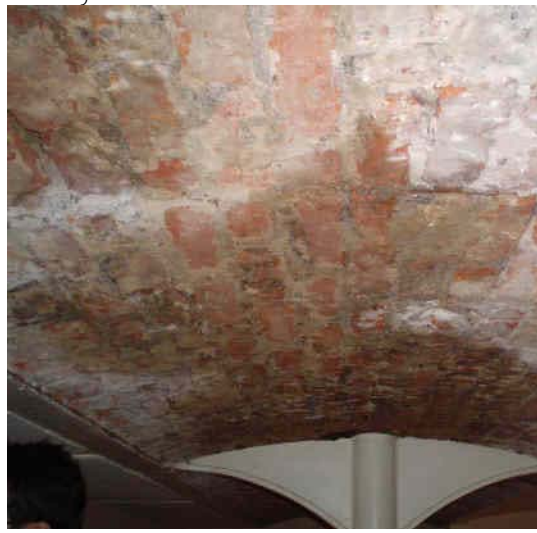
De-bonded
Ceiling
